Protecting your home

European House Borer Fact Sheet

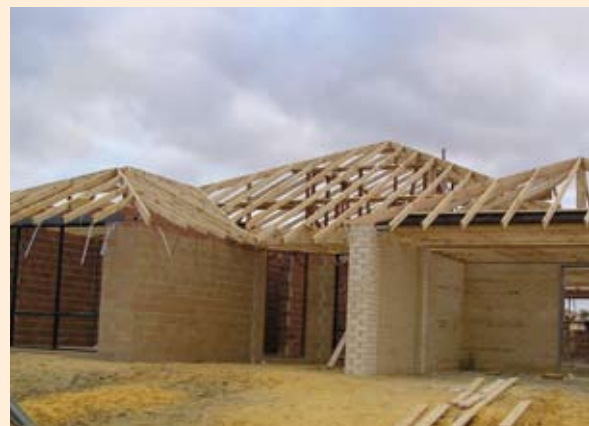
This home has been built with untreated pine, and is at risk from EHB infestation. Recommended actions, including the use of treated pinewood, will reduce the risk of infestation and spread.

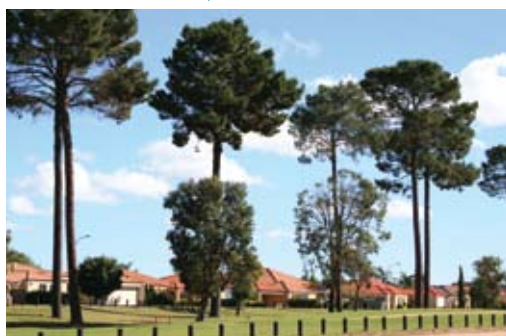
Relatively new homes located close to infested pine trees, such as Ellenbrook, are at a higher risk of infestation

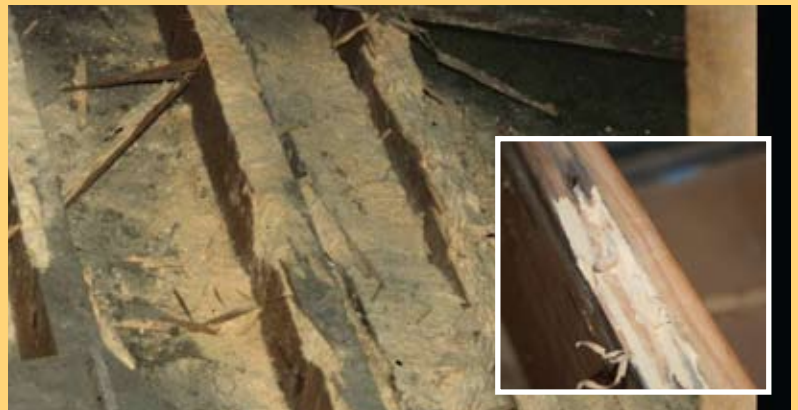
EHB damage

The EHB adult beetle lays its eggs in cracks, holes and joints in dead pine trees, dead parts of living trees, and untreated pine timber.

The damage is created by EHB larvae that hatch from the eggs. Because EHB can live in its larval state for 2-12 years without detection, significant boring and damage can occur. When EHB re-infests the same piece of timber, boring will continue until no viable wood remains. Structural collapse may then occur.

Adult EHB beetles create oval-shaped emergence holes in the timber, running in line with the grain of the wood. Dust and droppings may be seen on the floor below the timber where the adults have emerged.

EHB larvae tunnel through wood, packing tunnels or galleries with wood dust and droppings as they go. As they near the surface, narrow blisters along the grain of the wood may also be seen. Where there are exposed untreated pine beams or pine products, larvae may be heard chewing the timber.

It is only when the adult beetle emerges through exit holes that infestation can be determined. Even the 1-2 mm exit hole can go unnoticed, although the danger of re-infestation over 2-3 generations (10-15 years) can be avoided through EHB vigilance, and regular pest control inspections of high risk houses.
