# Pest destroys timber

European house borer (EHB), *Hylotrupes bajulus* Linnaeus, is a destructive pest of pine. If allowed to become established it can cause major structural damage to buildings.

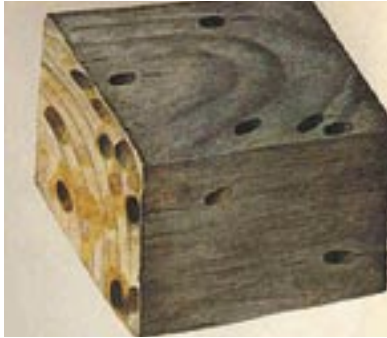
**Off-cut of timber exhibiting oval-shaped exit holes caused by emerging adult beetles.**

- Characteristic oval-shaped holes running with the grain on the surface of infested timber from which the adult beetle has emerged. Oval-shaped holes are about 5mm by 10mm in size.

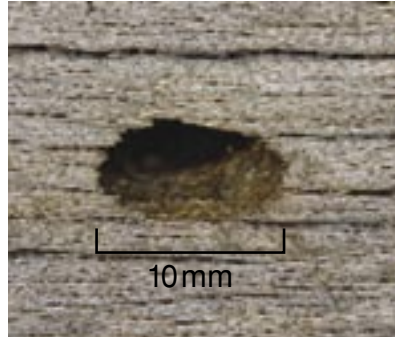
**Close-up of adult beetle exit hole.**  
– Picture not to scale (CD Pless and G Schweiger UT E&PP)

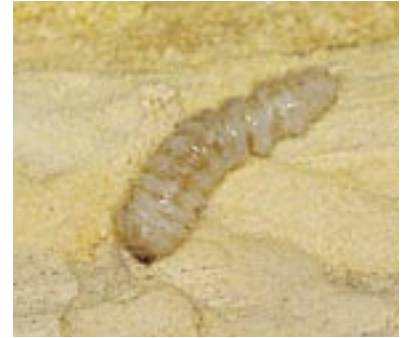
**Exposed larvae boring through timber.**  
– Picture not to scale (Clemson University USDA Cooperative Extension Slide Series)

- Galleries within the timber are formed by the boring larvae and are frequently tightly packed with frass. Galleries within the timber rarely break through the surface of the timber and therefore are seldom detected. However, long, blister-like swellings under the surface of the thin layer of uneaten wood caused by the tightly packed frass may be evident.

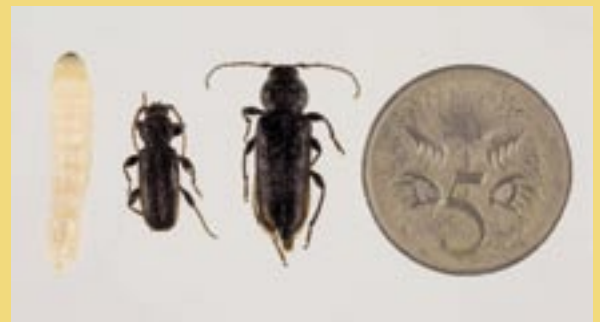
**Comparison of European House Borer and larvae with a five-cent piece.**

- Adult beetles which are brownish-black to black and have a slightly flattened appearance. The beetle's wings are usually all black and may have distinctive white patches. The top surface of the first body segment behind the head has two raised, black, shiny knobs, like eyes. Adults are about 8-25mm in length with antennae about half as long as the body.

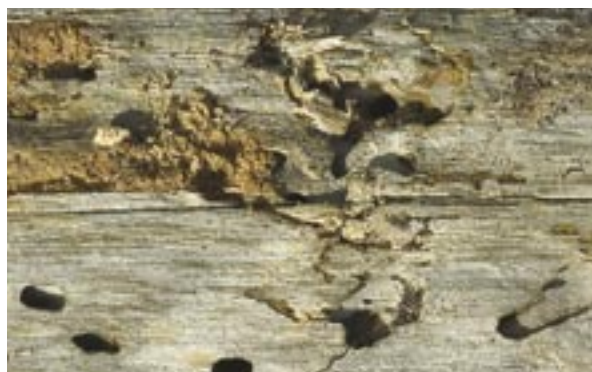
**Damage to a log caused by the European House Borer.**

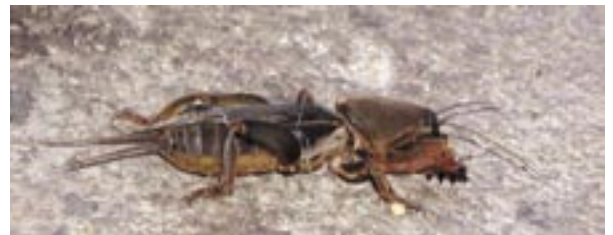
**A state of confusion: The EHB (left) is commonly confused with the Mole Cricket (right) and the Longicorn (centre).** Images not to scale. (Dept. of Agriculture, WA).

"The main difference is that the Longicorn eats only hard woods, whereas EHB is restricted to soft woods. It also attacks live woods, usually at a point of damage, whereas EHB will bore only into dead wood.

"Although the longicorn looks similar, it has antennae as long as the beetle, whereas antennae on EHB only comes about halfway down the body.

"Eucalypt Longicorn also has yellow patches on its back, rather than white and is brown in colour, unlike the black EHB."

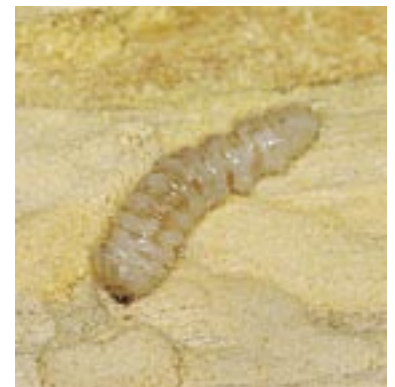
**Exposed larvae boring through timber.**
